GATEKEEPER
INSPECTIONS

REPORT SUMMARY

INSPECTION CONDITIONS

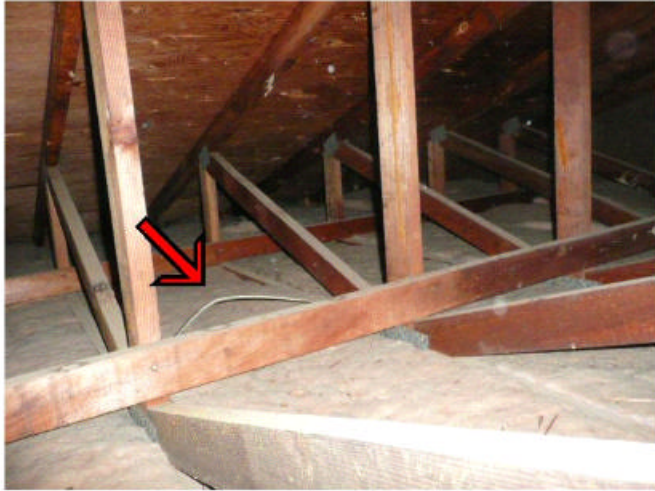
6. Recommend additional 9" of insulation in the attic area eventually.

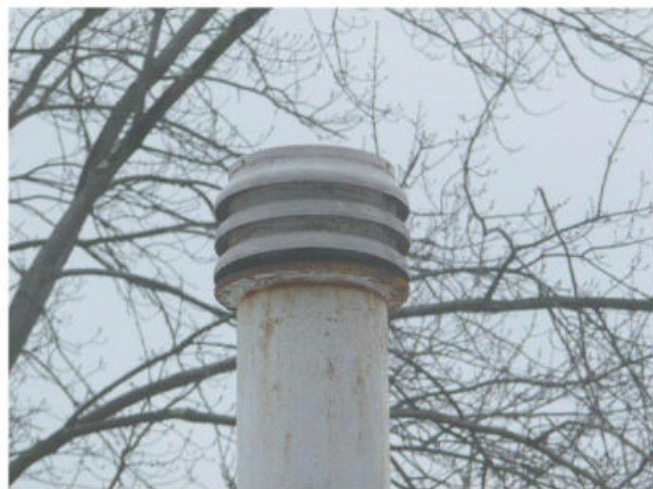
Brick, Metal.

Metal- Appears serviceable, Corroded. **Recent servicing is noted to the metal and the brick chimneys- see the chimney sweep' s report.**
